।। नहि ज्ञानेन सदृशं पवित्रमिह विद्यते ।। DR. VITHALRAO VIKHE PATIL FOUNDATION'S VITHALRAO VIKHE PATIL COLLEGE OF ENGINEERING

Green campus Policy

2020-2021

Dr. Vithalrao Vikhe Patil Foundation's College of Engineering, Ahmednagar

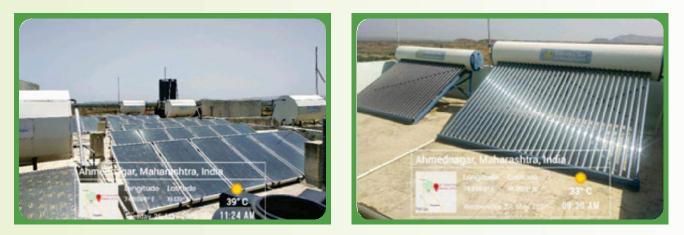
Figure 7 : ETC and FPC solar water heating system

The project has installed at total capacity of 20,400 liters per day solar hot water system on various roof tops. Both ETC and flat plate type solar water heating system on the following building rooftops.

Solar Water Heating Provisions in the campus			
Building	Solar water heating provision (LPD)		
Kaveri Hostel	3000		
Hostel A	2000		
Hostel B	2000		
Staff quarters	1000

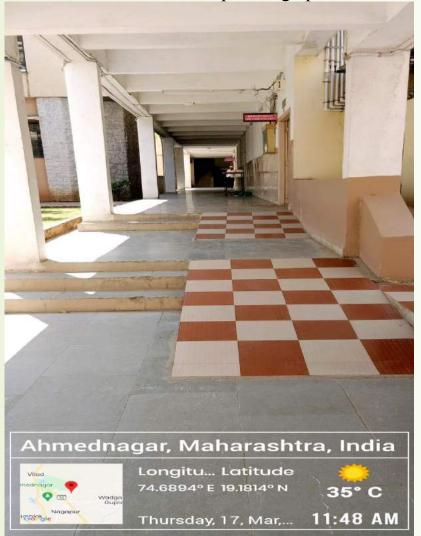
Figure 29 : Images showing entry ramps andhandrails along with signage

The project being a hospital and medical college, accessibility is an important aspect. Considering the use of stretchers, trolleys, wheelchairs, etc, the project has provided hindrance free movement by providing ramps, lifts, general signage, accessible toilet etc.

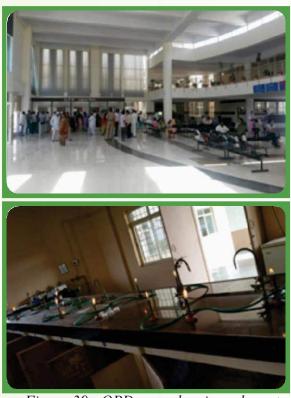
Figure 39 : OPD area showing adequate daylight & cross ventilation in lab

Adequate daylight levels helps in improving the indoor environment quality and helps reduce energy consumption during daytime. It is integral to design of a building and also helps in adding value to the space. The inclusion of daylight in spaces makes spaces inviting and productive. The project design includes adequate daylight illumination in the interior spaces by providing atrium and adequate windows.

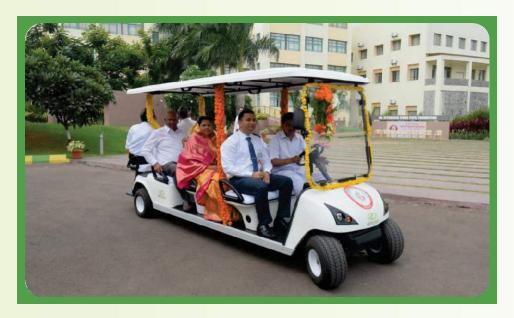
Figure 47 : Battery operated vehicle in campus 'KG- 6+2'

The project has provided one battery powered vehicle of 8 seater capacity (KG - 6+2) from Kinetic Green. The academic campus with 'no vehicle zone' caters a comfortable and convenient means of internal commuting by this vehicle. Electric vehicles produce no greenhouse gas (GHG) emissions, and therefore are considered 'green' because they have no emissions in the place where they are used. The purchase order of the battery powered vehicle is attached as Annexure 8.

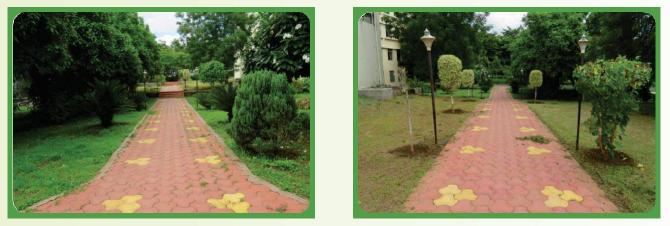
Figure 48 : Images showing shaded pedestrian pathways in the campus

The campus is very much pedestrian-friendly and enables access to everyone. It constitute shaded continuous pathways of uniform width and height and obstacle-free to provide better pedestrian accessibility, comfort and safety.
